# SKYS Property Inspection Consultants

## PROPERTY INSPECTION REPORT

77 Sunset Strip, Hollywood CA  
Inspection prepared for: Marilyn Monroe  
Inspection Date: 8/17/2011 Time: 8:25 am to 11:15 am  
Age: 2004 Size: 3650 sf  
Weather: Sunny  
Inspection#:007sample

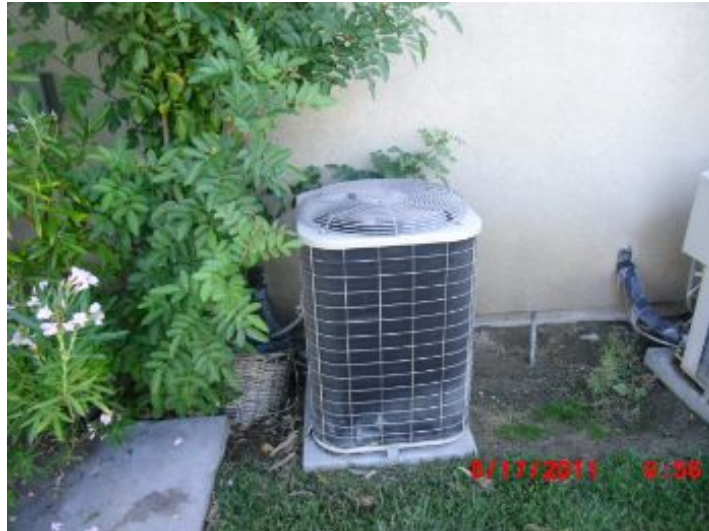
Compressor Type: electric  
 Location: The compressor is located on the exterior grounds.  
 Observations:  
 • Upper level compressor did not operate(2)

Upper level compressor did not operate(2)

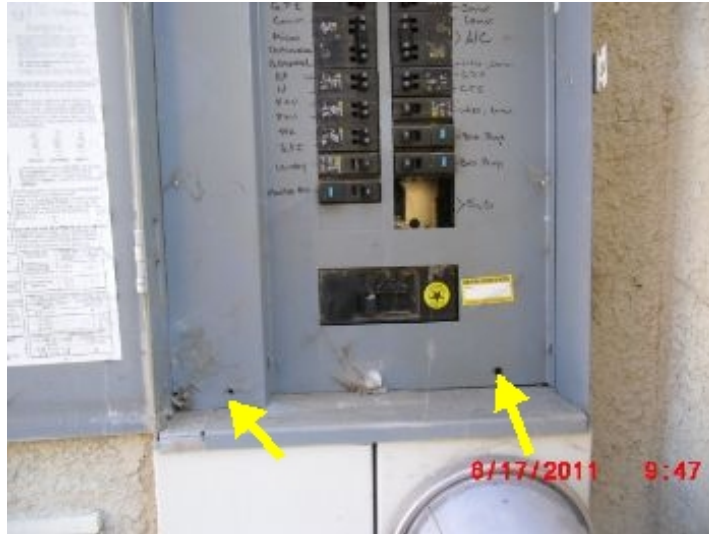
- Panel cover screw(s) missing.
- Open breaker panel slot(s) at panel box cover. Electrocutation hazard.

Panel cover screw(s) missing.

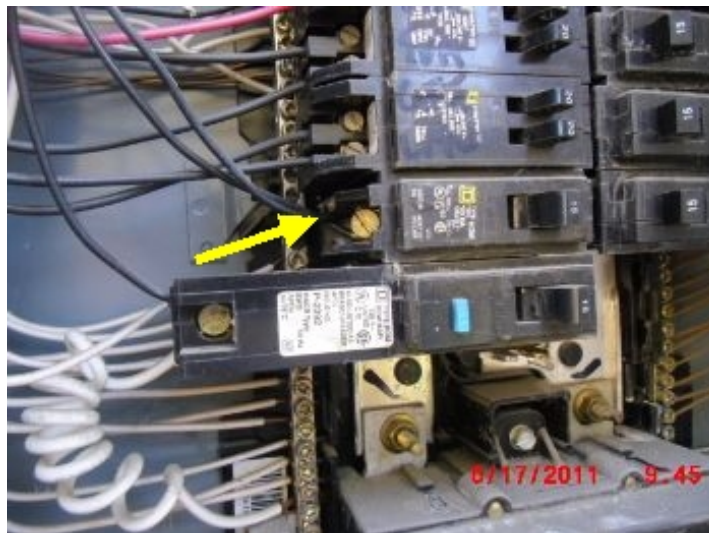
- One 15 amp breaker double lugged-two wires in lieu of one(2)
- AFCI Square D breakers, type HOM115AFI, on recall(2)

One 15 amp breaker double lugged-two wires in lieu of one(2)

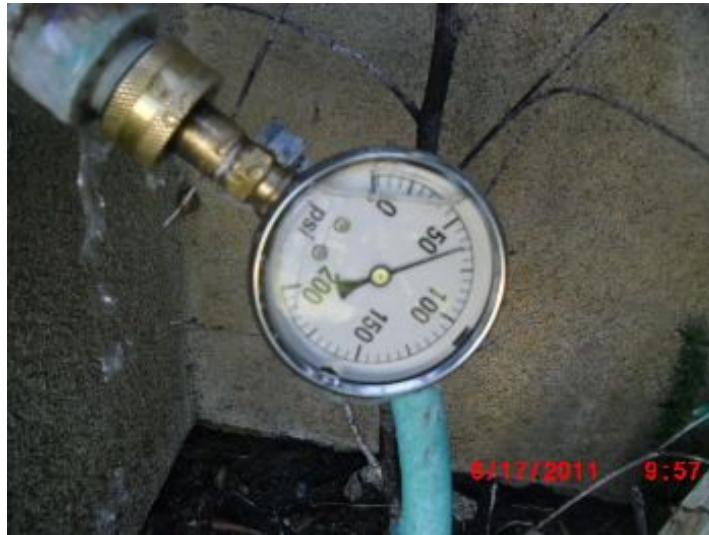
**65 psi-in normal range**

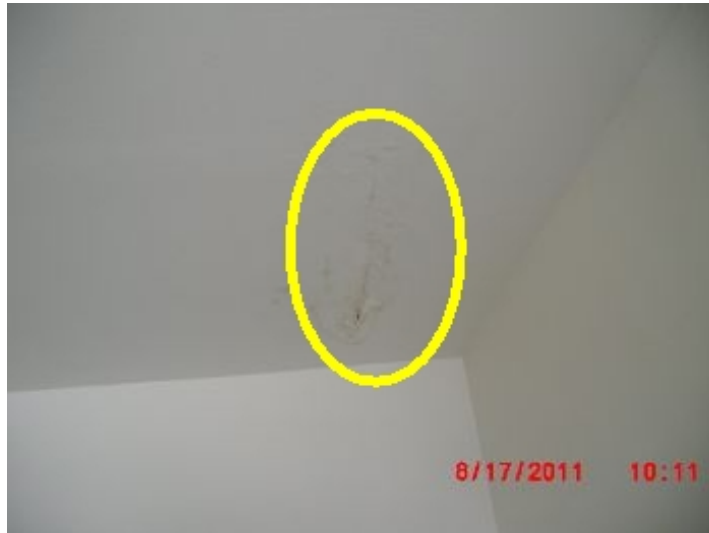
Plumbing System		
Page 11 Item: 5	Exterior Faucet Condition	<ul style="list-style-type: none"> <li>• Broken handle-rear faucet*</li> </ul>
Garage		
Page 14 Item: 10	Rafters & Ceiling	<ul style="list-style-type: none"> <li>• Water damage on ceiling below master bath-needs repair(2)</li> </ul>

**Water damage on ceiling below master bath-needs repair(2)**

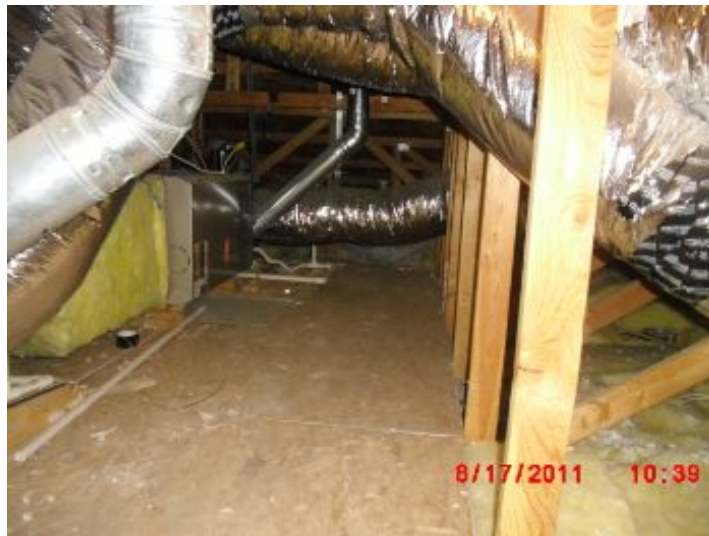
**Appears serviceable**

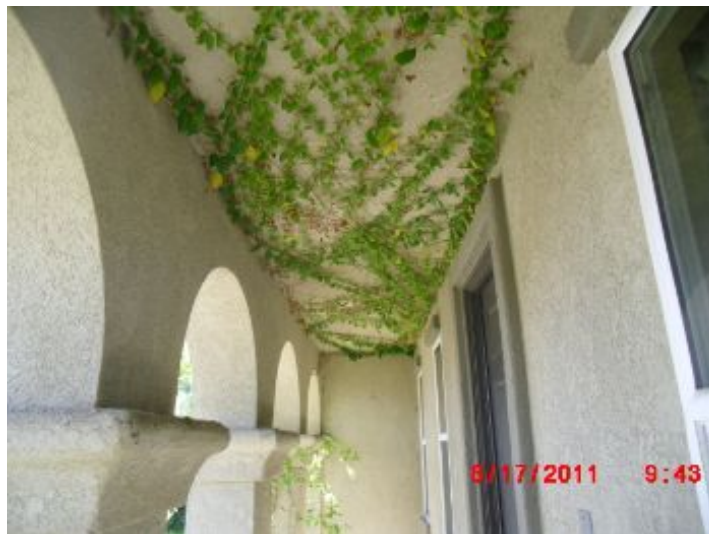
Trim remove front vines\*

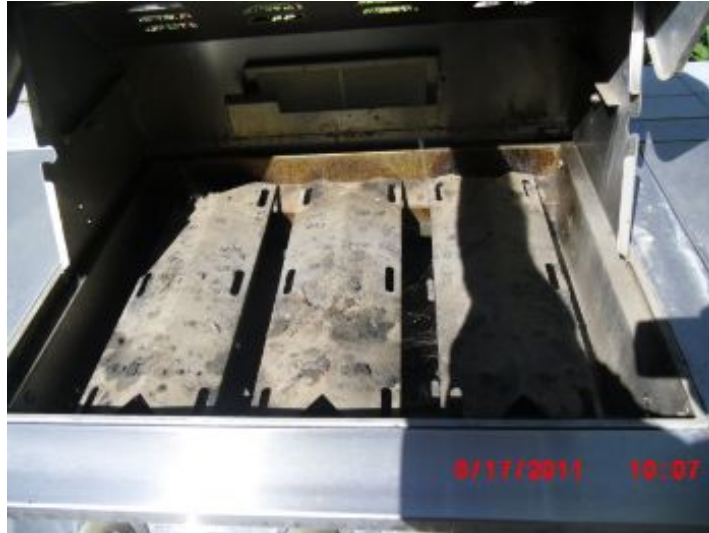
**Barbecue missing grill\***

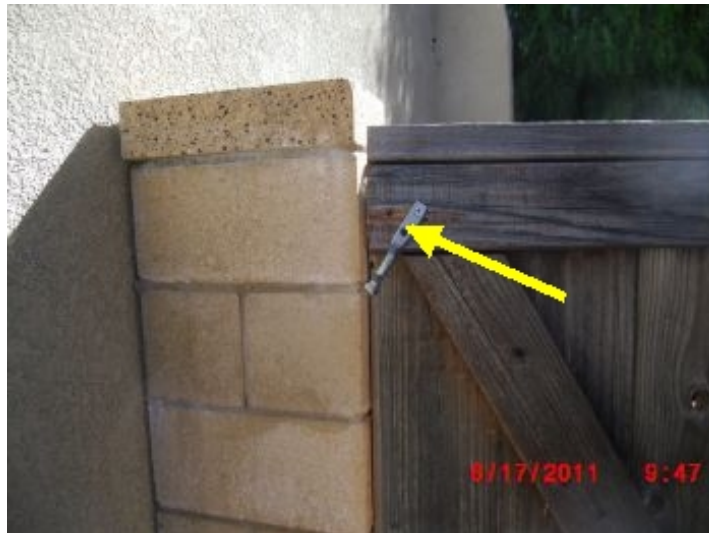
**South gate latch loose\***

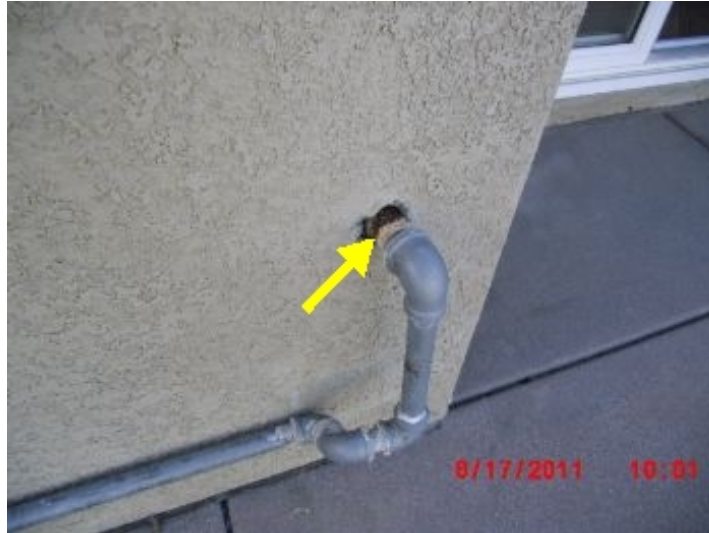
**Recommend sealing stucco at rear gas pipe\***

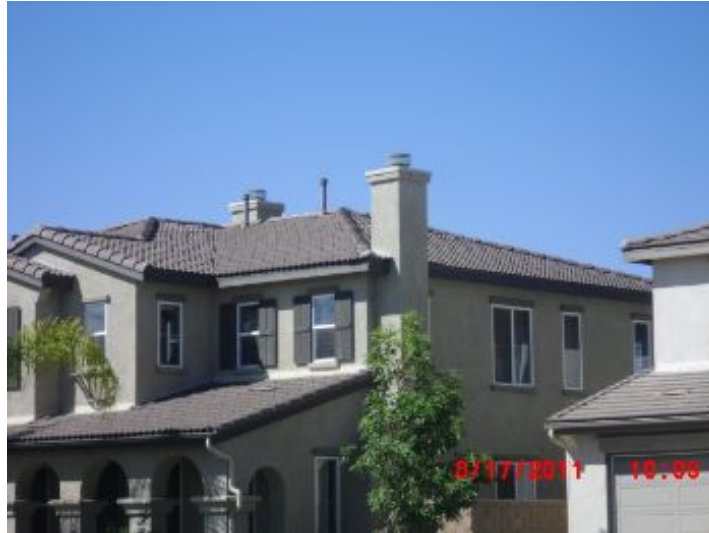
**General condition appeared serviceable**
